TECHNICAL NOTE 4263

EFFECT OF PRIOR AIR FORCE OVERTEMPERATURE
OPERATION ON LIFE OF J47 BUCKETS EVALUATED
IN A SEA-LEVEL CYCLIC ENGINE TEST

By Robert A. Signorelli, James R. Johnston, and Floyd B. Garrett

Lewis Flight Propulsion Laboratory
Cleveland, Ohio

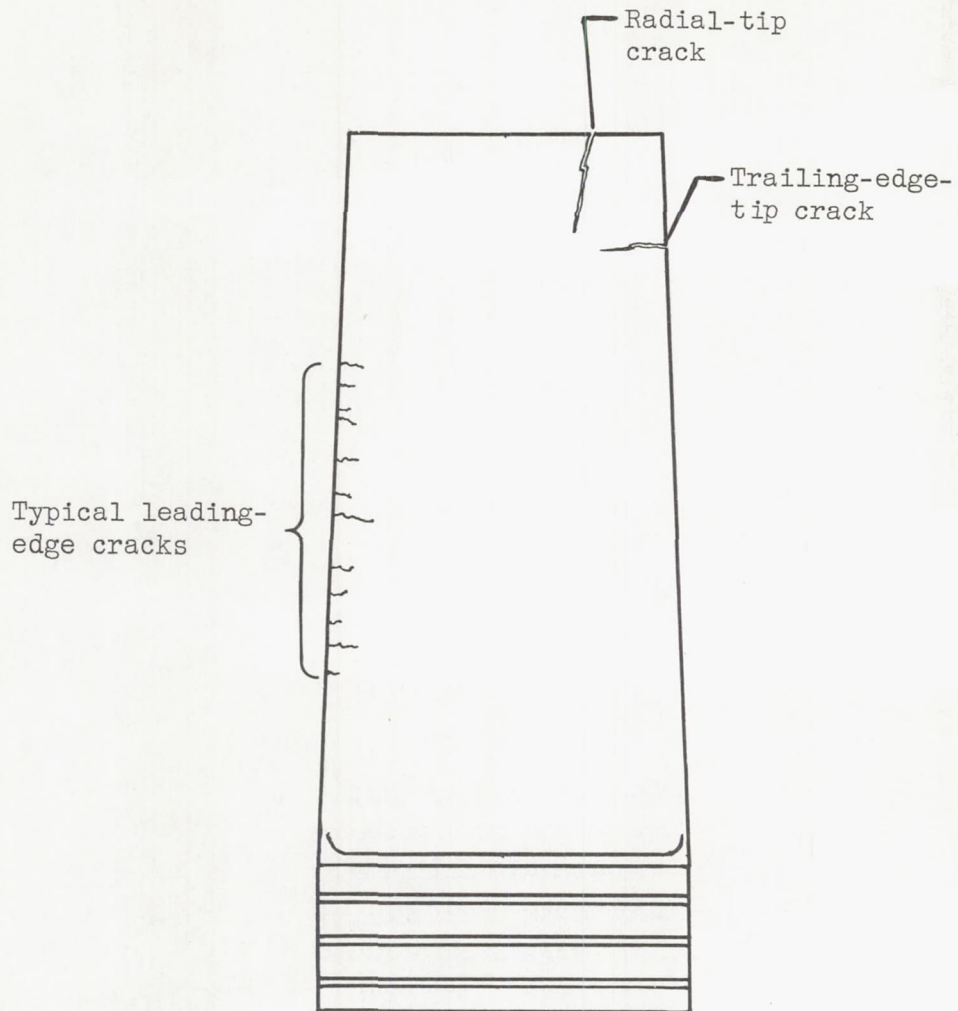
Macroexamination of buckets. - Buckets were examined for cracks, using post-emulsifying zyglo, after intervals of about 40 hours of rated-speed operation. The cracks were classified (fig. 3) as follows: (1) leading edge, (2) radial tip, and (3) trailing-edge tip. To follow the progression of cracks, photos were taken of a sample of about 20 cracked buckets after the 198-hour inspection and after every subsequent inspection. A double exposure was taken of the cracked buckets; the first exposure used an ultra-violet light to define the cracks, and a normal flash was used to show the entire bucket.

Figure 3. - Crack classification.

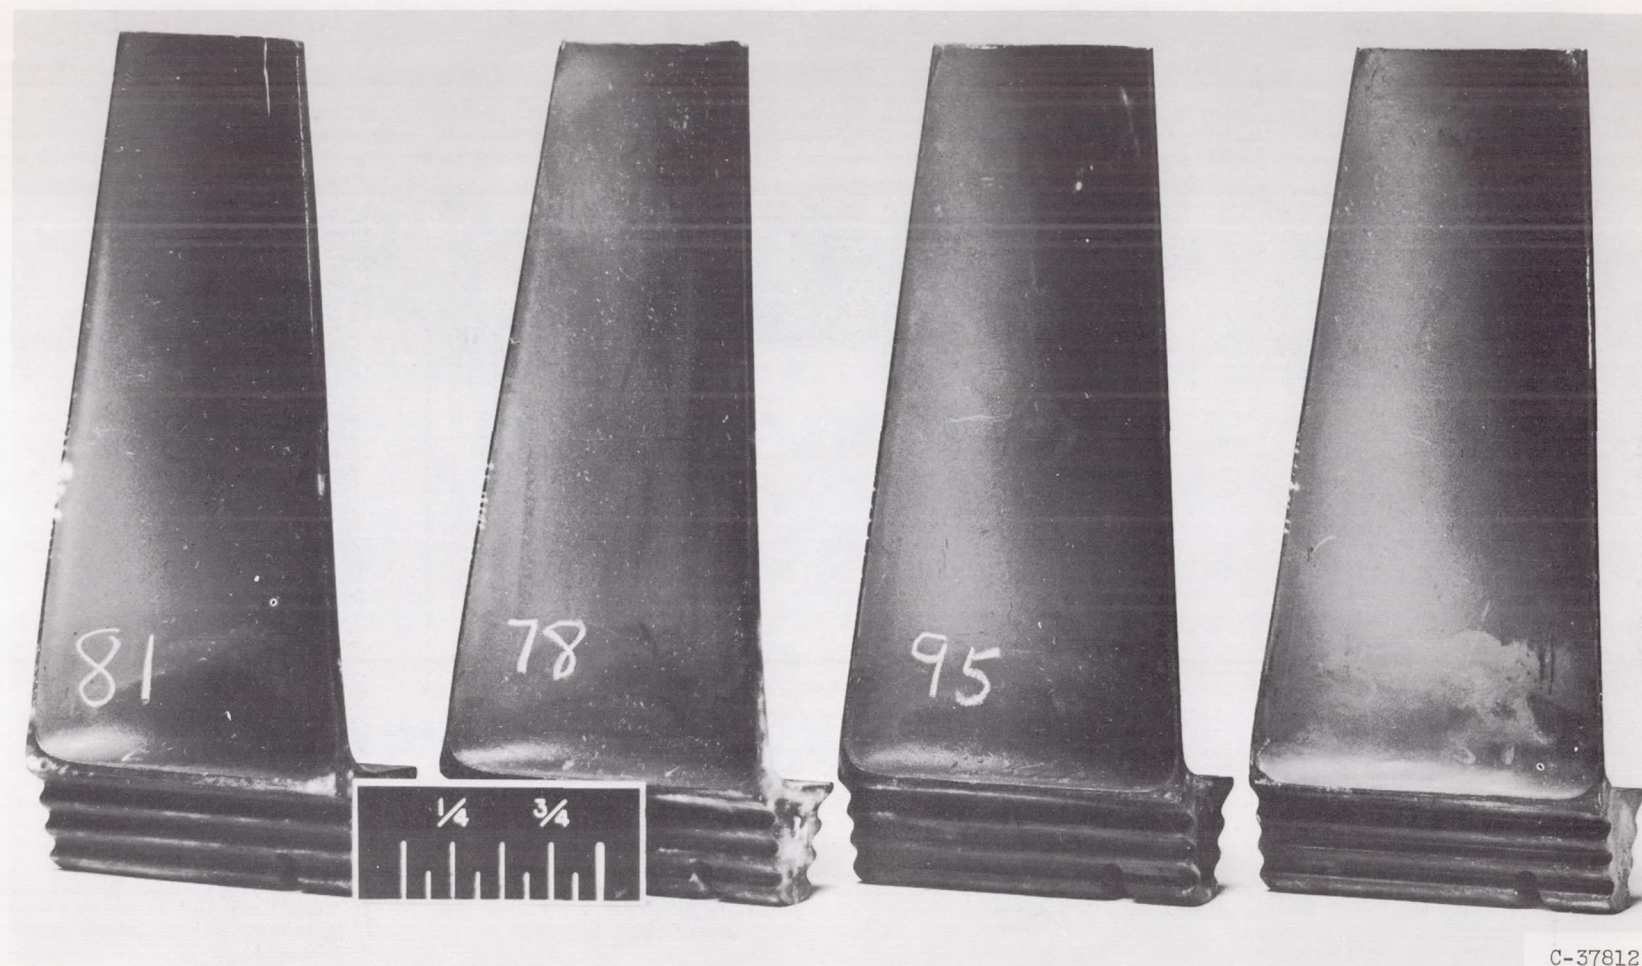
(a) Inspection, 198 hours.

Buckets ran for long periods of time without fracture after the inception of cracks. The one bucket that fractured ran 572 hours from the time cracks were first noted until it fractured. Photos of some of the buckets showing the progression of cracks during the course of the test are presented in figure 4. The depth of cracks did not increase very rapidly, as shown in figures 4(a) and (b), which illustrate the cracks after 198 and 500 hours of operation, respectively. After 500 hours, the largest leading-edge crack in bucket 81 elongated more rapidly (figs. 4(c) and (d)) and the bucket fractured in 652 hours (fig. 4(e)). The cracks in the other three buckets shown are relatively short after 660 hours, when the test was concluded (fig. 4(f)).

Figure 4. - Progression of cracks in representative buckets.

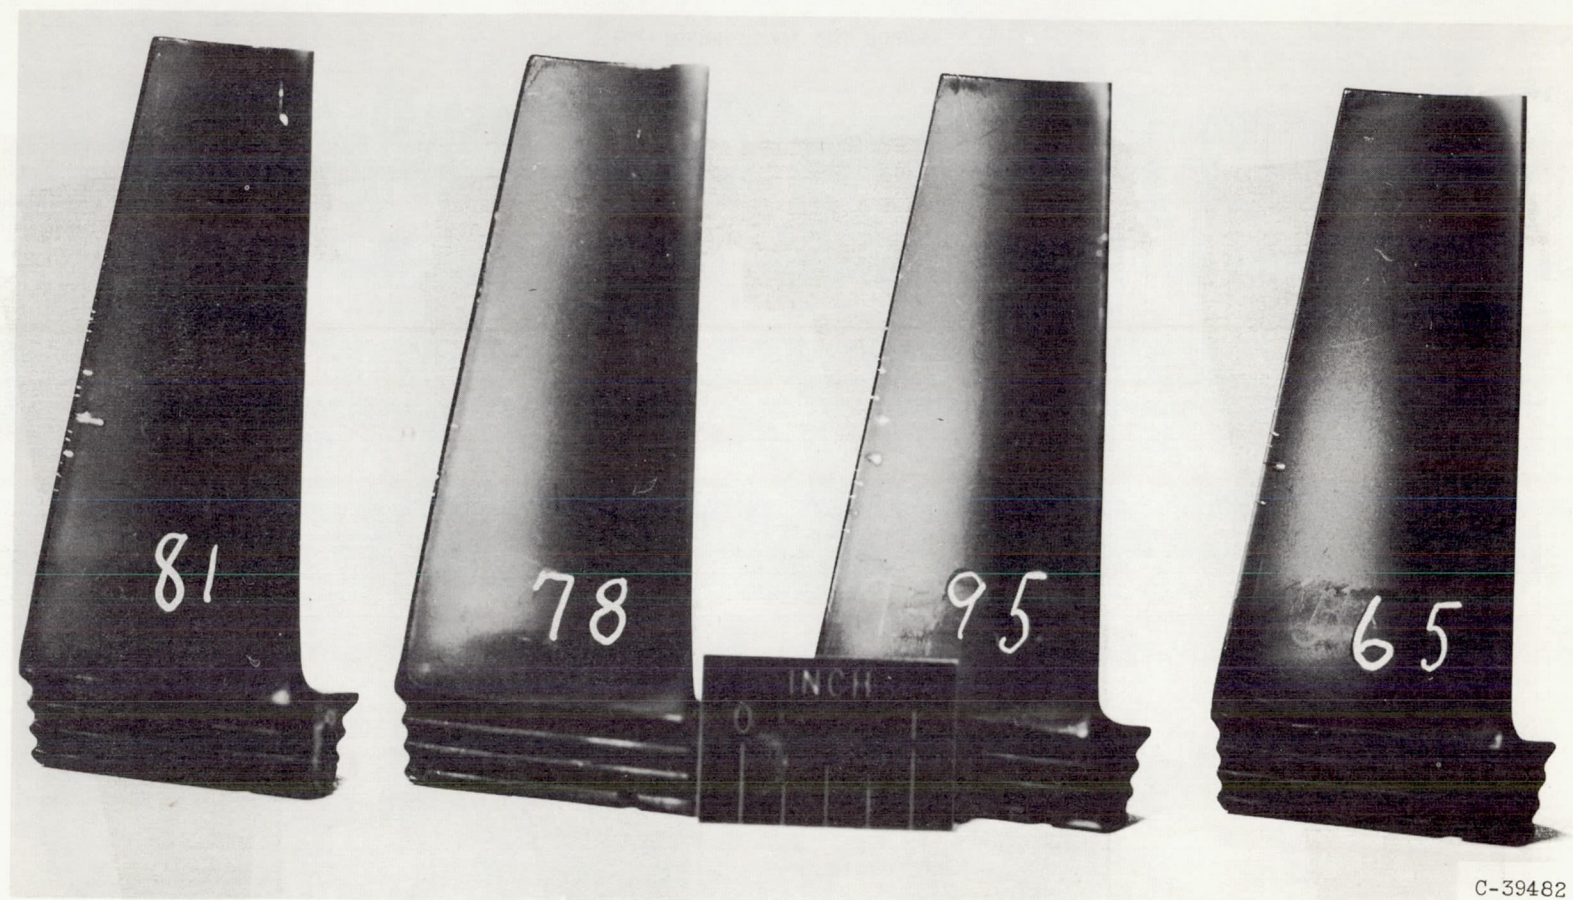
(b) Inspection, 500 hours.

Figure 4. - Continued. Progression of cracks in representative buckets.

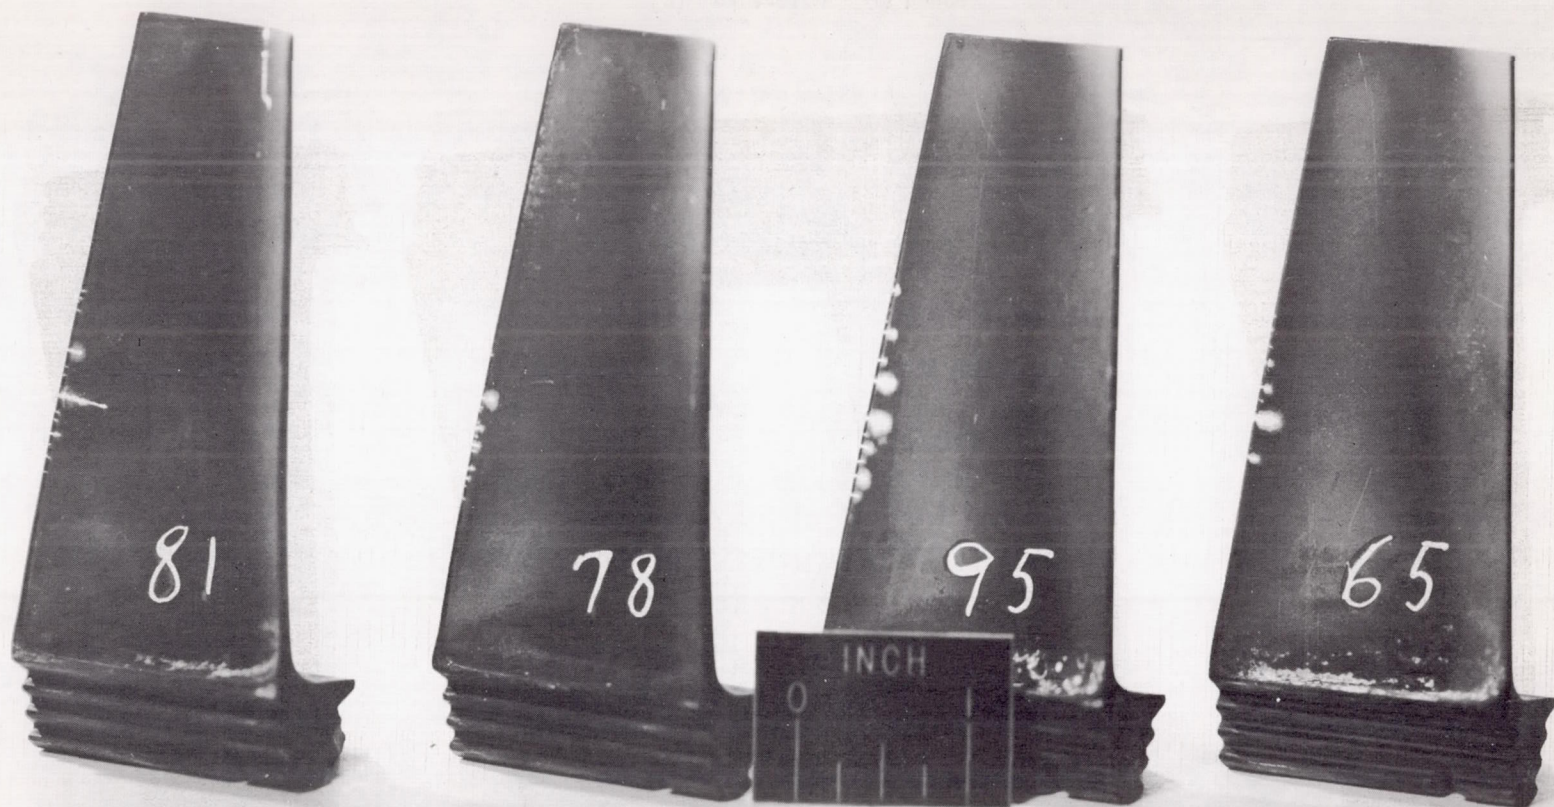
(c) Inspection, 580 hours.

Figure 4. - Continued. Progression of cracks in representative buckets.

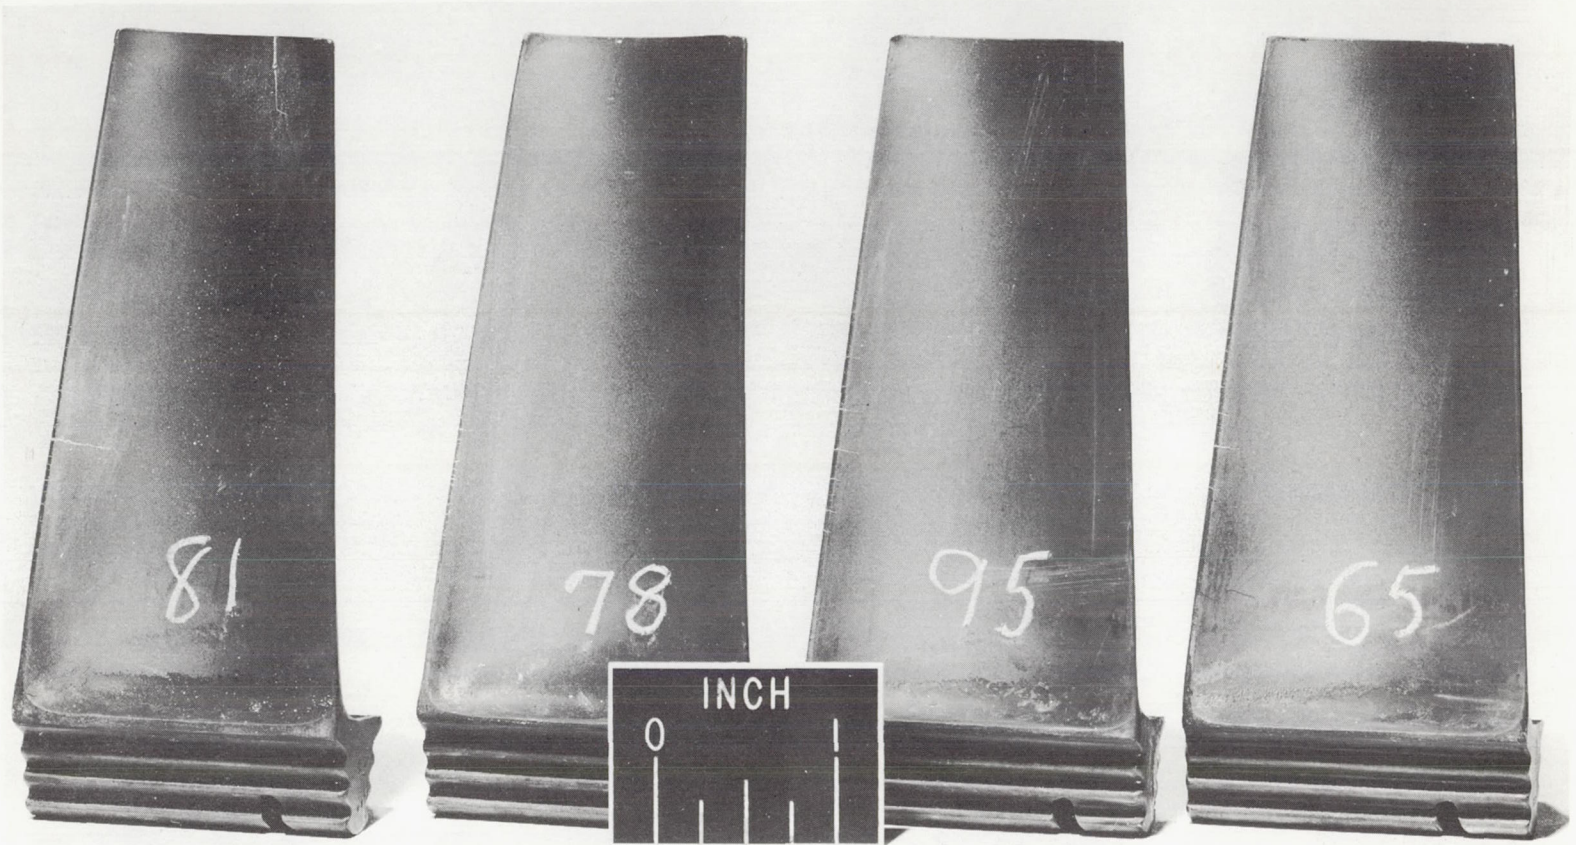
(d) Inspection, 620 hours.

Figure 4. - Continued. Progression of cracks in representative buckets.

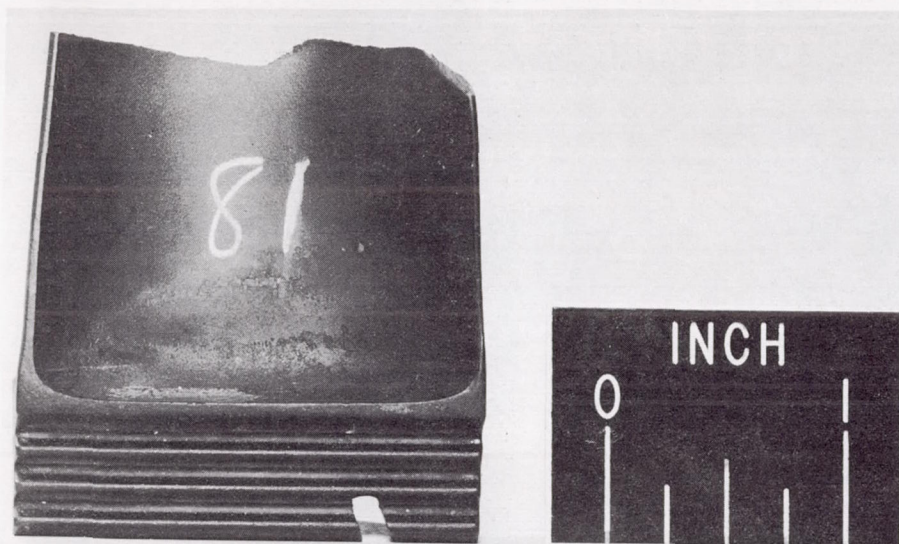
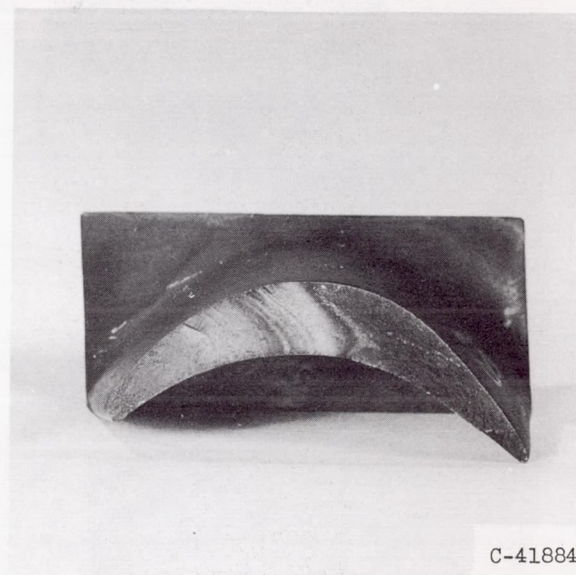
Bucket failures. - Only one bucket had fractured when the test was discontinued after 660 hours at rated speed. The fracture occurred in an overtemperated and reaged bucket (group 3) after 652 hours of operation. However, 81 buckets (84 percent) were cracked at the conclusion of the test after 660 hours (table III). Cracked buckets were first detected in the second zyglo inspection, which was performed after 80 hours. With the exception of the three buckets with trailing-edge tip cracks, all buckets were reinserted in the engine after zyglo inspection, and the test was continued to determine the rate of crack propagation.

The fracture surface of the one bucket that fractured in this investigation is shown in figure 10. The fracture surface is near the leading edge where failure began and at a point near the center of the chord length. The fracture appears intergranular near the leading edge and transgranular near midchord. The failure was propagated by fatigue from a leading-edge crack until the load-carrying area was reduced sufficiently to cause tensile failure.

(e) Bucket fracture from a leading-edge crack after 652 hours of operation.

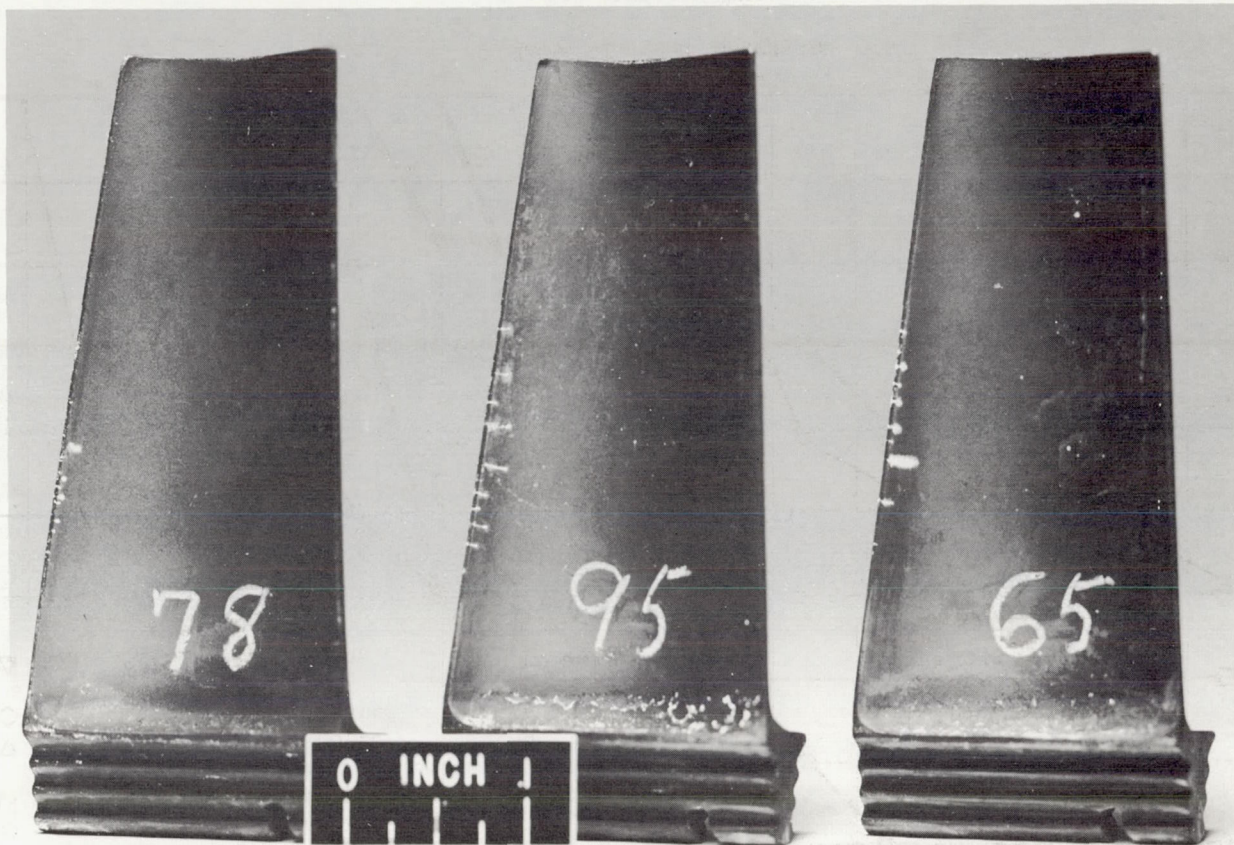
(f) Conclusion of test, 660 hours.

Figure 4. - Concluded. Progression of cracks in representative buckets.

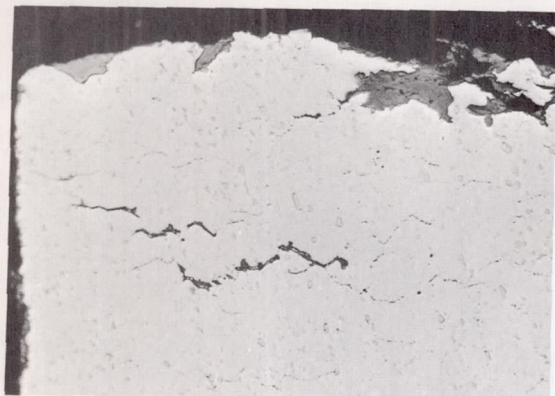
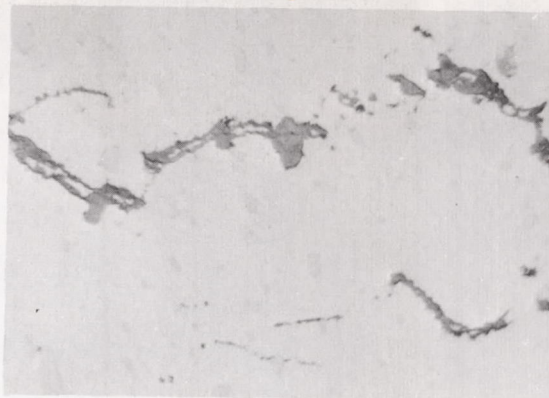
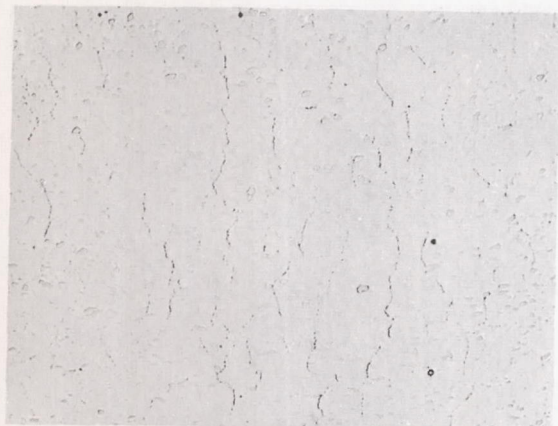
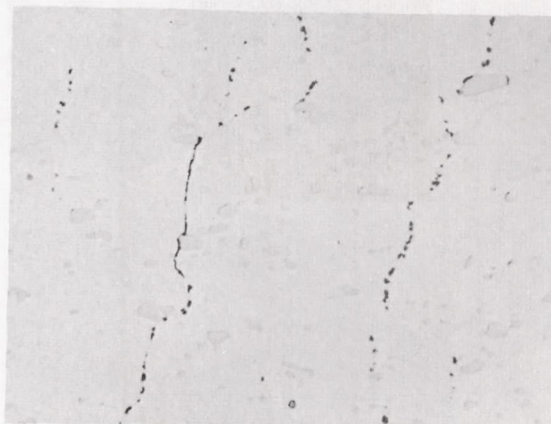
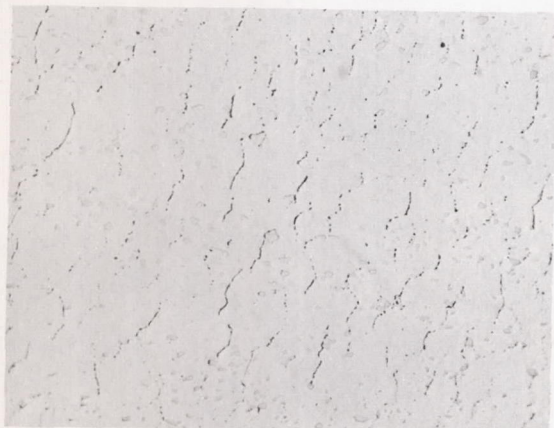
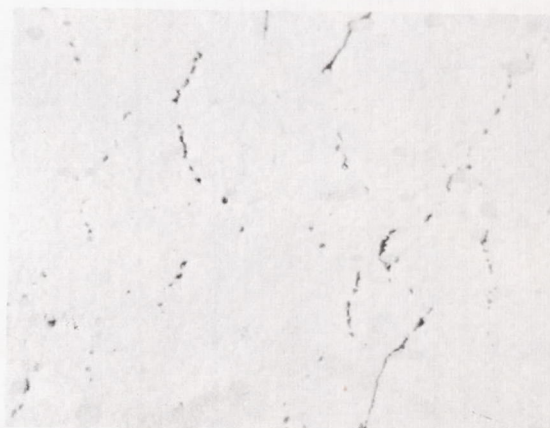
In addition to the continuous cracks near the leading edge, there were clusters of voids present in the grain boundaries of buckets. The voids were found in buckets from every group, but only specimens from the as-overtempered and the standard groups are shown in figure 9. The voids are in the grain boundaries transverse to the direction of centrifugal stress in the airfoil. They are found near, but not at, the leading edge and extend inward for a distance of about 0.2 inch.

As indicated in the results, clusters of voids were observed in the examination of microstructures after engine testing (fig. 10). The voids do not appear to be intergranular oxidation or rupture tears may be evidence supporting a theory that intergranular failure of metals at higher temperatures is caused by migration and collection of interstitial gases or vacant lattice sites, as suggested by Parker in 1944 (ref. 7) and others more recently (ref. 8). These voids have been seen in rupture specimens by others (refs. 9 and 10) and may be associated with the failure mechanism of leading-edge cracks.

Figure 9. - Voids in as-overtemperatured and standard S-816 buckets after 660 hours at rated speed (unetched).

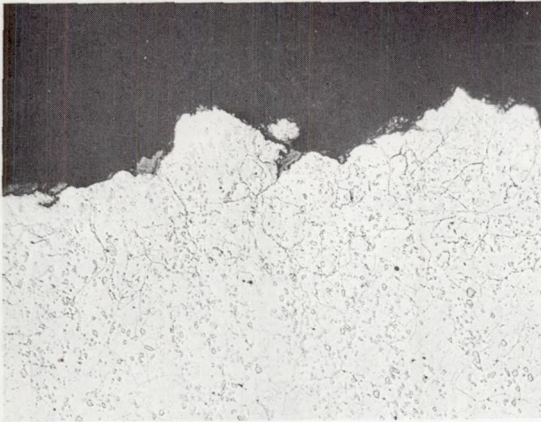
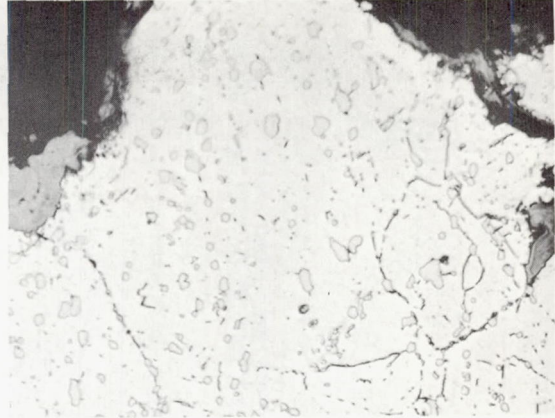
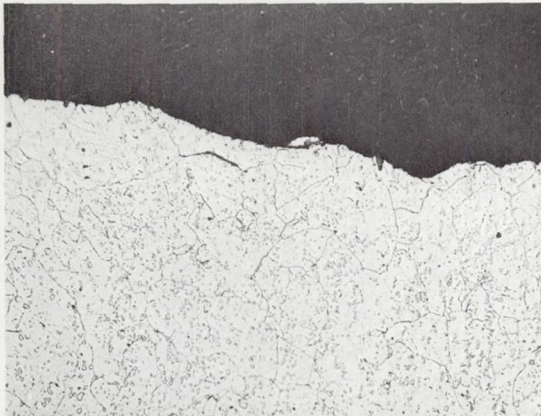
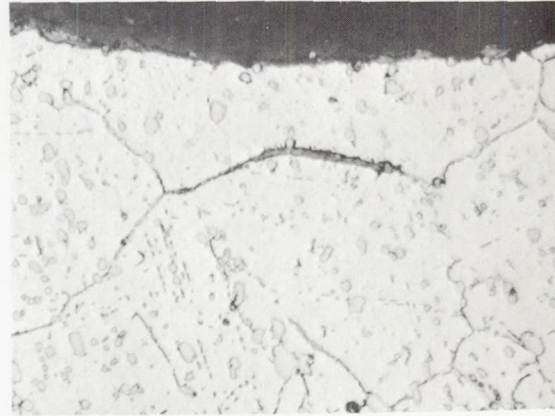
Intergranular near leading edge of bucket

Transgranular portion of fracture surface following above
(a) Bucket failure progressing from leading-edge crack.

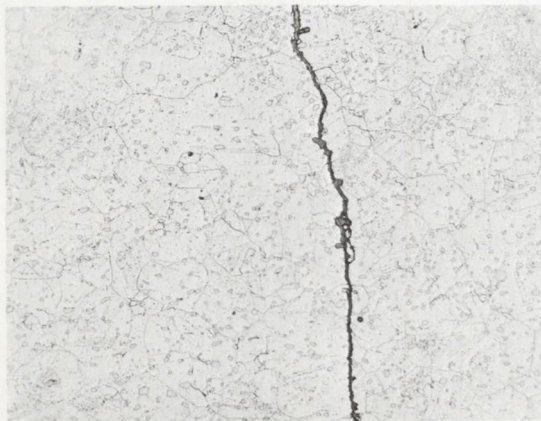
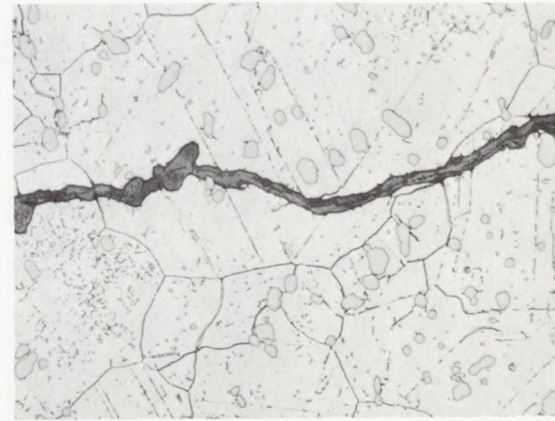
(b) Radial tip crack.

A typical radial-tip crack shown in figure 10 is a transgranular fatigue failure. Buckets ran for 500 hours with such radial-tip cracks and did not fracture.

Radial-tip cracks that developed in a number of buckets were the secondary mode of failure in this investigation. Radial-tip cracks are attributed to vibratory fatigue and generally are not associated with overtemperature. The trailing-edge tip of the bucket, where this crack occurs, undergoes relatively little temperature change compared with the midspan portion of the bucket during overtemperature; and any overtemperature effects would probably be much less severe.
